STS-121 Flight Readiness Review

External Tank Project (ET-119)

June 16, 2006

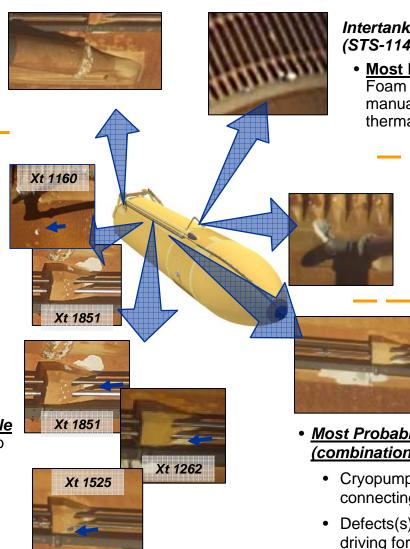
<u>Most Probable Cause</u> <u>Scenario(s)</u>: Secondary impact or multiple subsurface voids resulting in observed foam loss

- <u>Xt 1160 Most Probable Cause</u> <u>Scenario:</u> Work induced damage or delta pressure void in adjacent repair
- <u>Xt 1851 Most Probable Cause</u> <u>Scenario:</u> Cryopumping divot event due to voids, cracks and/or delaminations

- <u>Xt 1262 and 1841 Most Probable</u> <u>Cause Scenario</u>: Divoting due to an internal process-induced void and delta pressure
- <u>Xt 1525 Most Probable Cause</u> <u>Scenario:</u> Impact during ascent due to TPS, ice or other Shuttle element debris

• <u>Most Probable Cause Scenario:</u> Foam loss caused by voids in the close-out manual spray foam subjected to ascent thermal and pressure environments

- <u>Most Probable Cause Scenario</u>: Divot caused by cryoingestion through and into cable
- LH2 PAL Ramp (STS-114-T-03)
- <u>Most Probable Cause Scenario</u> (combination of the following)
 - Cryopumping of outside air through leak path connecting to atmosphere
 - Defects(s) and or damage to initiate failure or driving force to peel foam from tank

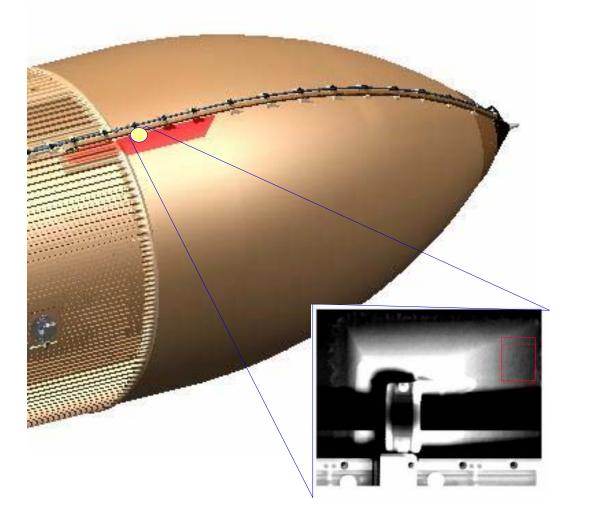
Station 828: Small cluster of porosity in extension spray.

Area of cluster = 1.25" dia

Mass = 0.017 lbm

NSTS 60559: 0.026 = Risk Assessment Mass

Notes: Geometric defect, tied to bracket also observed at STA 794. (No divot expected due to depth) "Unexpected divot" max mass = 0.011 lbm

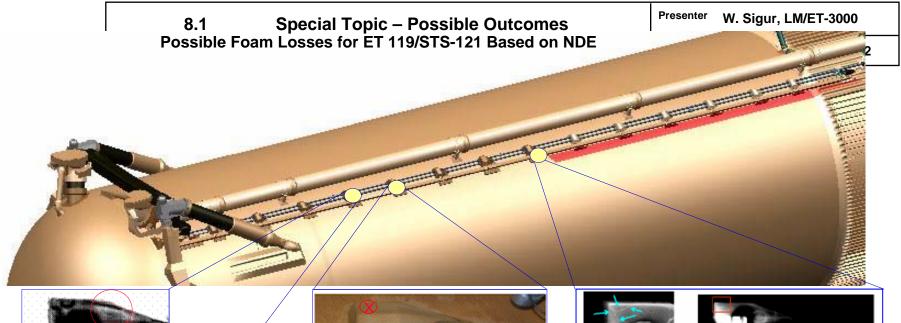
Station 1787: Small cluster of porosity in PDL flow lines

Area of cluster = 0.5" dia

Mass = 0.011 lbm

NSTS 60559: 0.084 = Risk Assessment Mass Station 1722: Two void locations

Area = 0.3" dia and 0.4" dia

Mass = 0.003; 0.003 lbm, resp

NSTS 60559: 0.084 Ibm = Risk Assessment Station 1528: Flow lines with a void

Area = 1.0" dia

Mass = 0.008lbm

NSTS 60559: 0.084 Ibm= Risk Assessment Mass

Note: Geometric defects, tied to bracket observed set STA 1399, 1528, and 1851. (no divot due to depth) "Unexpected divot" max mass = 0.011 lbm

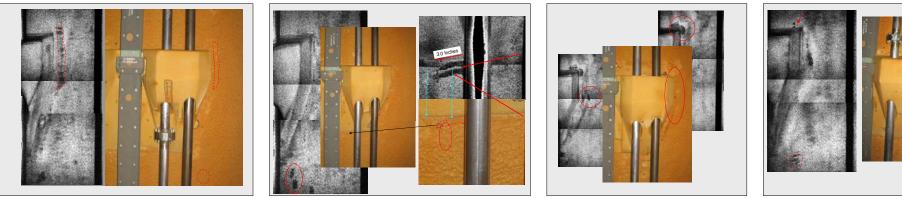
- NDE using shearography identified potential risk for crushed foam losses
 - Crushed foam indications noted at stations 1151, 1205, 1528, 1593, 1722 and 1787
 - Visual inspections also performed in area to assess risk
 - Visual methods validated by test
 - Typical scans noted

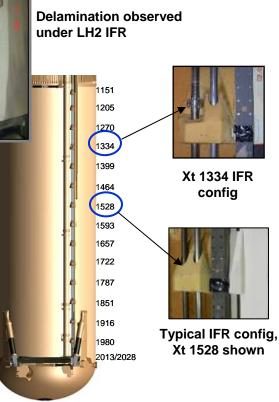
- Background (cont.)
 - STS-114 Foam Loss Events Root Cause Investigation Summary
 - Acreage loss at Xt 1851 most probable cause identified as cryopumping divoting due to subsurface delaminations
 - Observed under acreage foam LH2 ice/frost ramp body on ET-120 'typical' IFR configurations (after 2 cryo / pressurization cycles)
 - Delaminations not observed under Xt 1334 IFR
 - Different configuration than typical LH2 IFR configurations
 - Damage mostly in NCFI within IFR footprint; although some PDL damage (IFR body)
